REPORT DOCUMENTATION PAGE		READ INSTRUCTIONS BEFORE COMPLETING FORM
1. REPORT NUMBER	2. GOVT ACCESSION NO. AD-A091131	3. RECIPIENT'S CATALOG NUMBER
4. TITLE (and Subtitle) Phase I Inspection Report Clear Lake Dam Lake Erie Basin, Erie County, NY Inventory No. 751		5. TYPE OF REPORT & PERIOD COVERED Phase I Inspection Report National Dam Safety Program

14. MONITORING AGENCY NAME & ADDRESS (if different from Controlling Office) Department of the Army 26 Federal Plaza New York District, CofE New York, NY 10287		12. REPORT DATE 22 May 1980

PHASE I INSPECTION REPORT
NATIONAL DAM SAFETY PROGRAM
CLEAR LAKE DAM I.D. No. NY 751
DEC #12D-493 LAKE ERIE BASIN
ERIE COUNTY NEW YORK

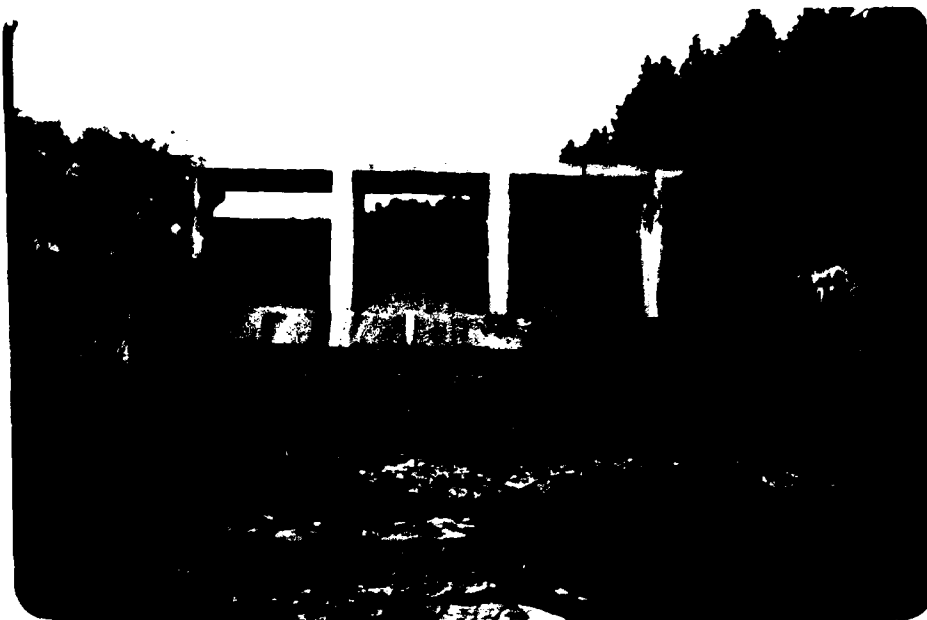
The spillway is mass concrete with an ogee crest, a concrete chute discharge channel and a highway bridge (with 3 piers tied into the spillway) traversing the spillway. (See Photos #4,5,6&7) The downstream face was originally stepped concrete, until 1966 when gunite and baffle blocks were constructed. During the storm of September 14, 1979, a portion of the gunite was lifted up from the downstream face of the spillway. (See Photos #4 & 6). The inspections revealed that the "J" bolts holding the gunite to the original concrete were rusted and loose, and the wire mesh reinforcing was rusted through in numerous places. Cracking at the junction of the gunite and original concrete, and also at the bottom of the ogee section has permitted seepage to enter the area between the gunite and the original structure. These factors coupled with the force of the spillway flow appear to be the cause of the gunite displacement. The gunite was removed by State personnel to facilitate the inspections. The gunite removed was placed on the right embankment near the spillway wall (See Photos #7 & 9). The remaining gunite was sounded and this indicated that portions of the ogee section, highway bridge piers, and the spillway walls have separated from the original concrete. The concrete of the original structure appears sound where observed.

1. The gunite on the spillway, spillway piers and walls is deteriorated and not properly bonded to the original concrete. Remove this gunite and repair as required. Also caulk all joints where the existing sound gunite abuts the original concrete.

Spillway Downstream Face
Photo #4

1. Repair the loose spalled and deteriorated gunite portions of the spillway, spillway piers and walls. Also caulk all joints where the existing gunite abuts the original concrete.

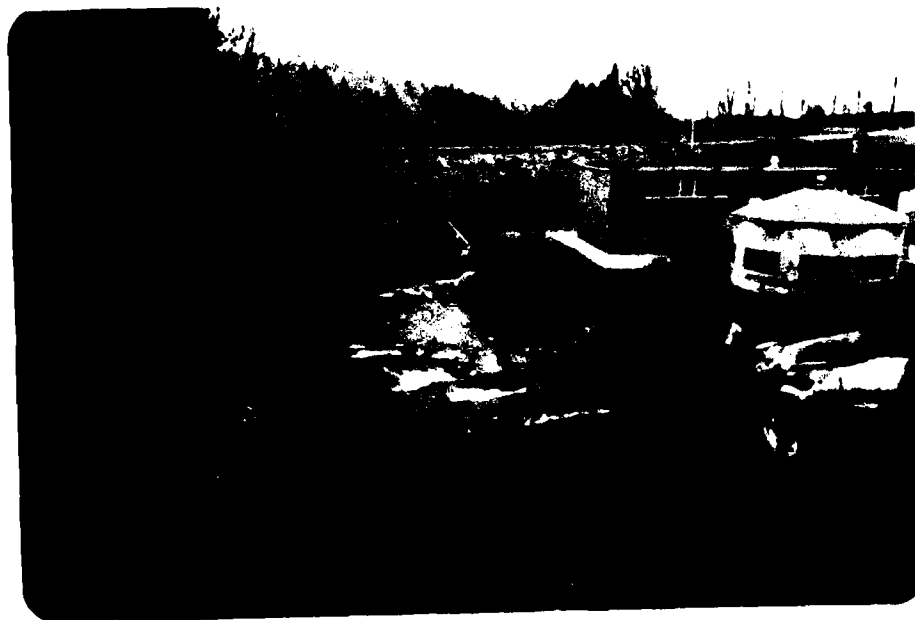
The downstream slope is estimated to be generally 1 vertical on 2 horizontal with no evidence of sloughing, subsidence, surface cracks movement or depressions. Four animal burrows were observed near the midpoint of the slope approximately 50 feet right of the spillway buttress. Also numerous small trees and low brush were evident on the right embankment. (See Photos #1, 2, 4 & 7) Numerous large trees were growing on the left embankment (See Photos #3, 4, 6 & 9).

Downstream Channel
Note, Highway Embankment & Treatment Plant
Photo #9
